ENGINEERING EXPERIMENT STATION  
BULLETIN SERIES No. 365

## EXPERIENCE IN ILLINOIS WITH JOINTS IN CONCRETE PAVEMENTS

A REPORT OF INVESTIGATIONS

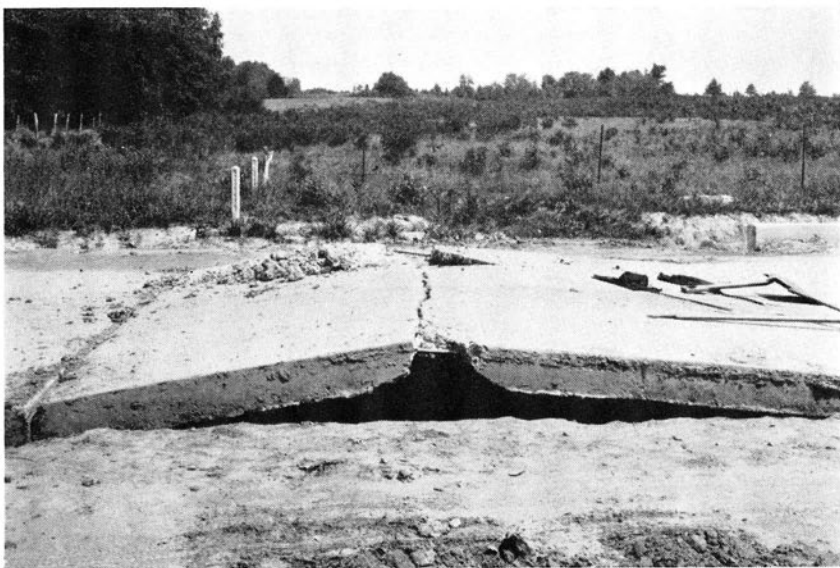
FIG. 1. TYPICAL BLOWUP IN CONCRETE PAVEMENT

Experience later proved that cracks could not be sealed with any of the available fillers against the entrance of foreign materials. Each time the pavement contracted, dirt entering the cracks prevented them from fully closing again on subsequent expansion. The action was progressive, the cracks becoming a little wider with each cycle of expansion and contraction. This eventually resulted in an actual lengthening of the pavement which was not absorbed by the changes in alignment, as was expected, and, as a consequence of the concentration of compressive stresses during periods of expansion, failures of the concrete commonly known as blowups occurred. Figure 1 is a photograph of a typical blowup.

tenance costs, that the various highway districts adopted the general practice of cutting transverse joints at those locations where blowups appeared imminent. At locations where blowups did occur, space for future expansion of the concrete was provided at the time the failure was repaired by leaving an opening in the slab and filling it with asphalt.

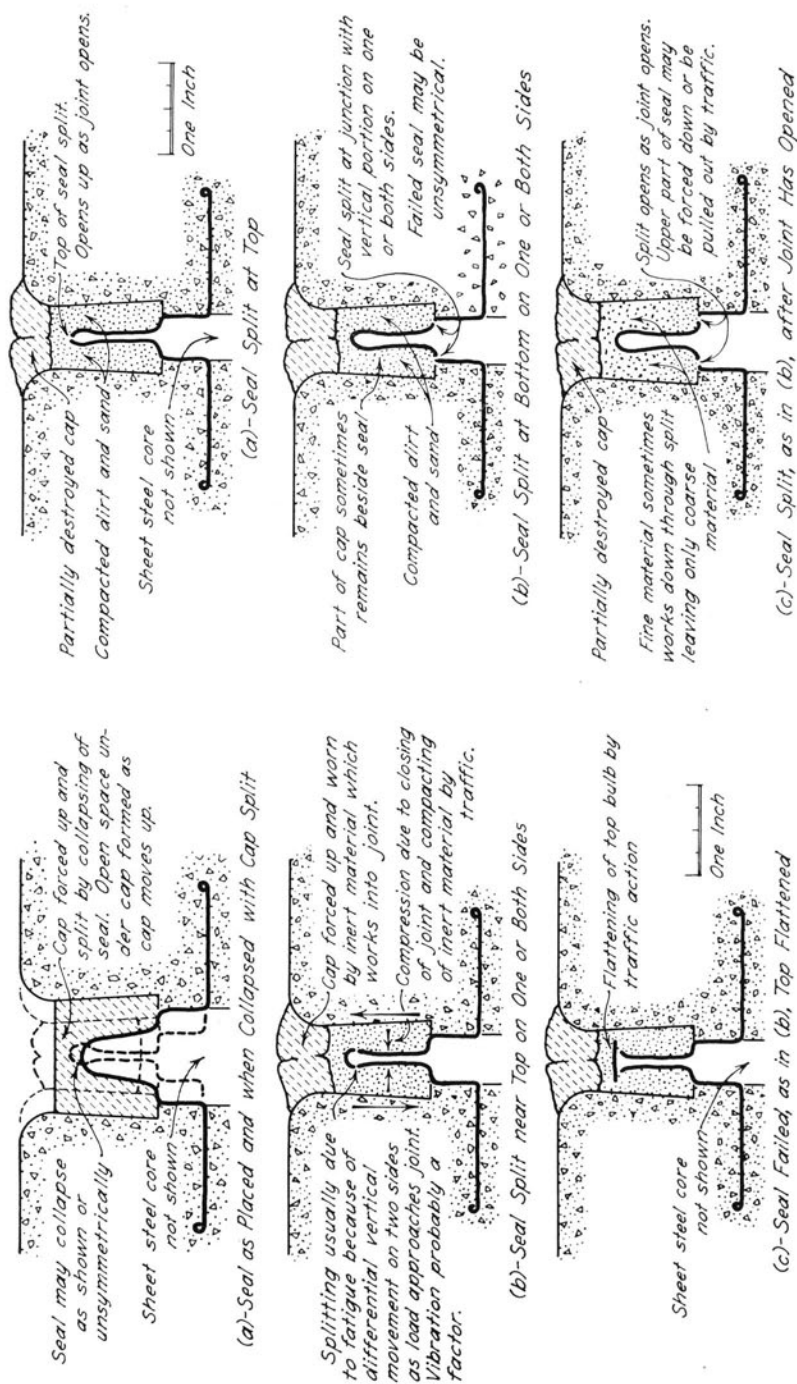
FIGS. 63 AND 64. TYPICAL FAILURES OF J-1 EXPANSION JOINT SEALS IN SERVICE

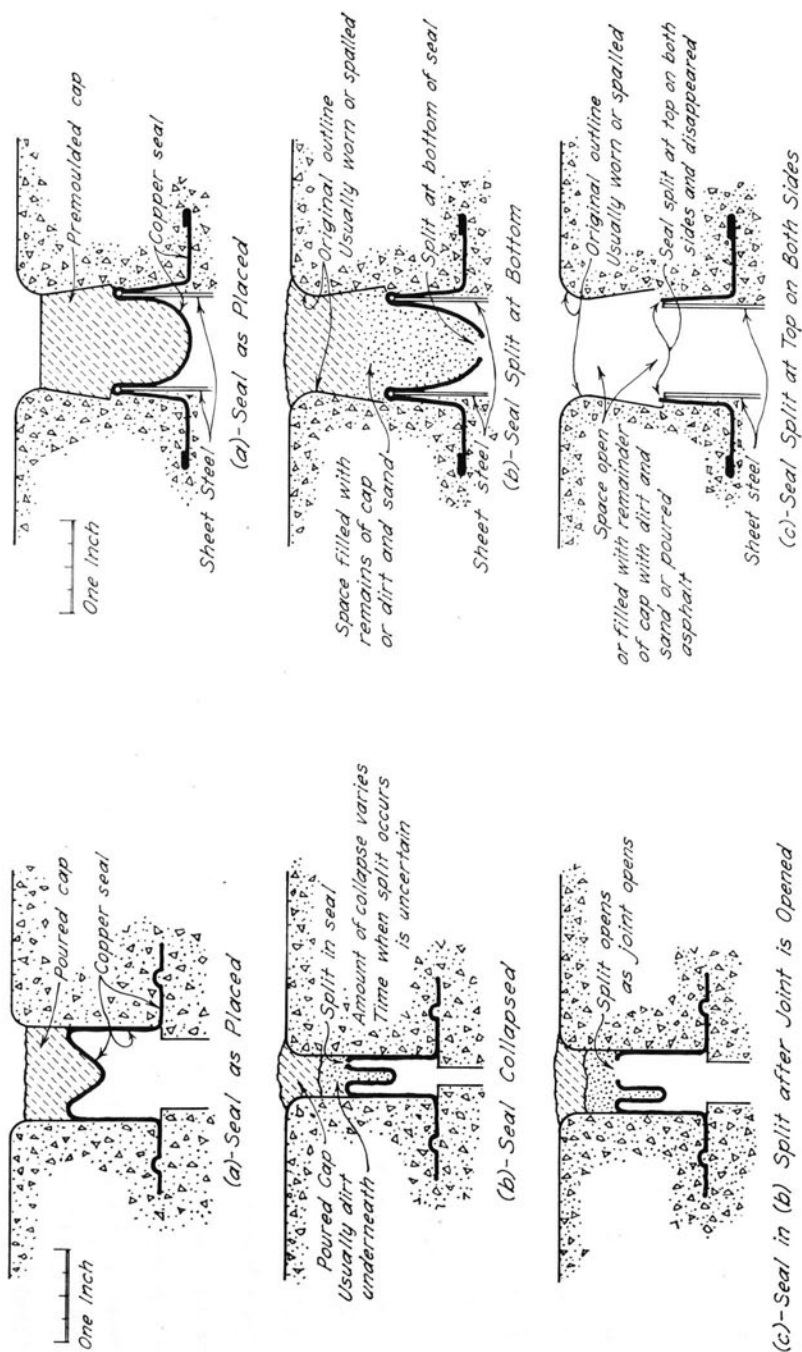
FIG. 65 (AT LEFT). TYPICAL FAILURE OF J-4 EXPANSION JOINT SEALS IN SERVICE

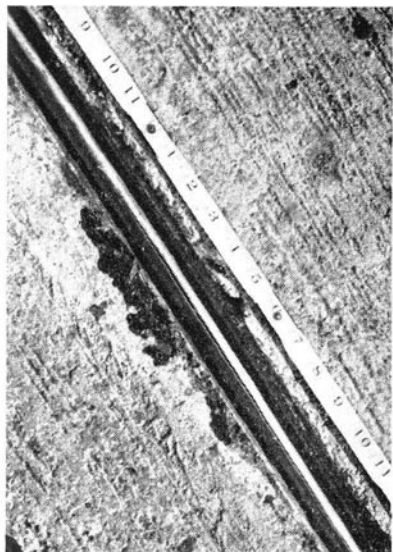
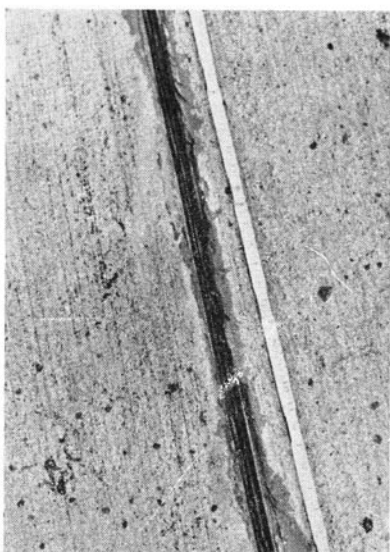
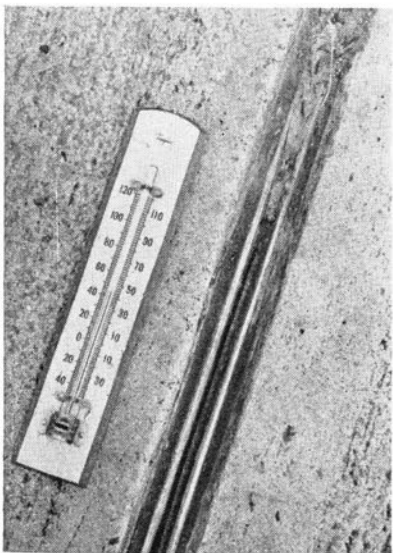
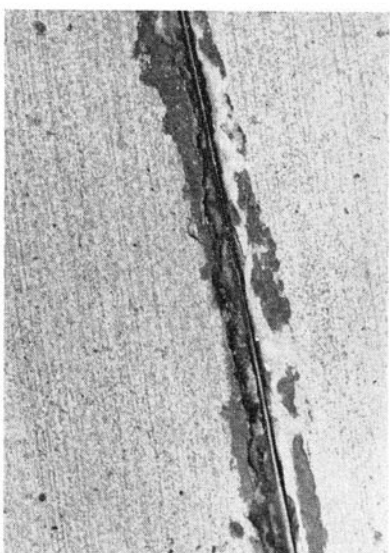
Typical examples of failures in top seals and end seals are shown in Figs. 67 to 73, inclusive. Figure 67 shows fractures in the top seal of a J-1 expansion joint. Figure 68 is typical of the failures in J-2

FIGS. 67, 68 (ABOVE), 69, 70 (BELOW). TYPICAL EXAMPLES OF FRACTURED TOP SEALS — RESPECTIVELY ON J-1, J-2, AND J-4 EXPANSION JOINTS AND ON J-2 CONTRACTION JOINTS (LATE DESIGN)

expansion joint top seals; Fig. 69 illustrates a condition prevalent in top seals of J-4 joints, while Fig. 70 shows a typical failure of a top seal on a J-2 contraction joint. The J-1, J-4, and to some extent the

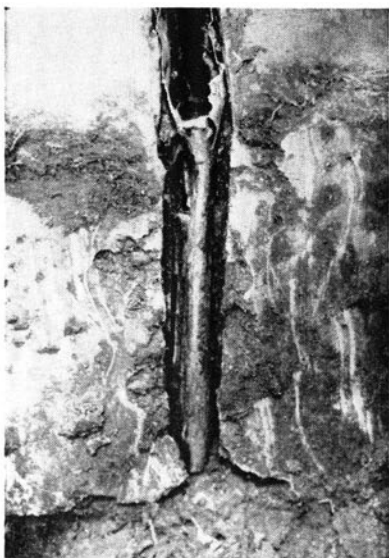
FIG. 71 (ABOVE, AT LEFT). TYPICAL EXAMPLE OF FRACTURED END SEAL ON J-1 EXPANSION JOINT

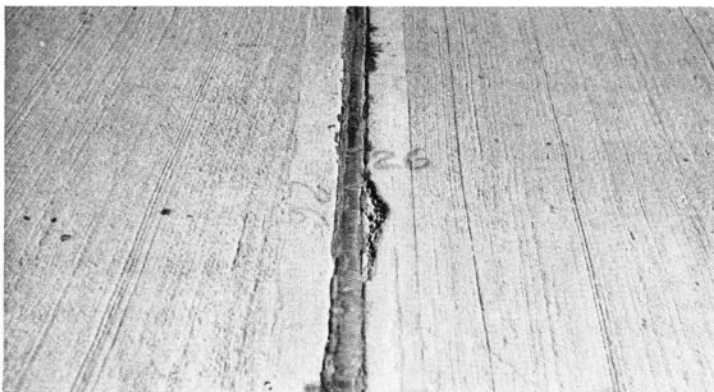
FIG. 74 (AT TOP). SLIGHT SPALLING  
ALONG J-1 EXPANSION JOINT

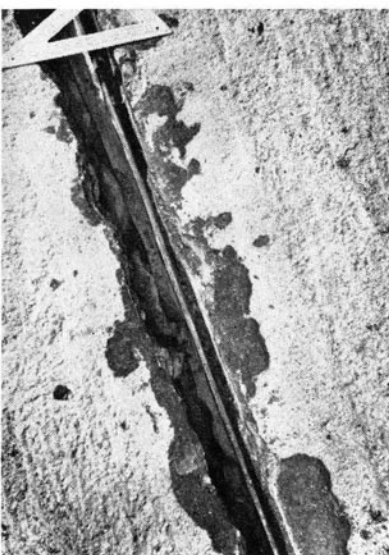
Figure 76 shows bad spalling along a J-2 expansion joint, another example of the result of poorly consolidated concrete under the flange of the seal. A case of slight spalling along a J-4 expansion joint is shown in Fig. 77. Figure 78 shows bad spalling along a J-4 contraction joint, caused by improper compaction of the concrete. A typical example of slight spalling along a 4-in. open joint is shown in Fig. 79.

FIG. 76 (AT LEFT). BAD SPALLING  
ALONG J-2 EXPANSION JOINT

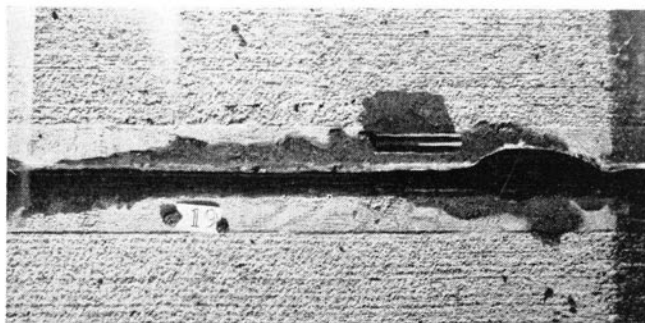
FIG. 77. SLIGHT SPALLING ALONG J-4 EXPANSION JOINT

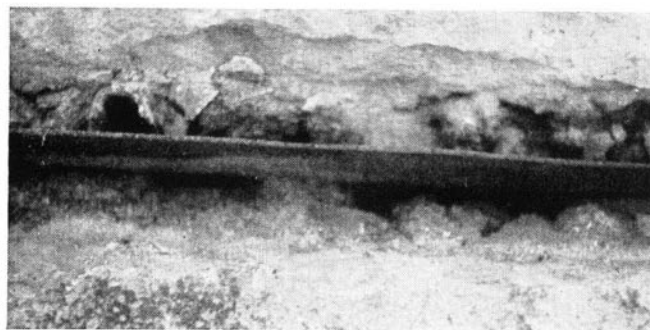
FIG. 78. BAD SPALLING ALONG J-4 CONTRACTION JOINT

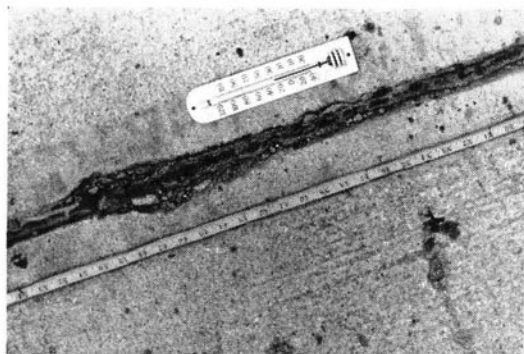
FIG. 81. SLIGHT SPALLING ALONG  
FIBER EXPANSION JOINT

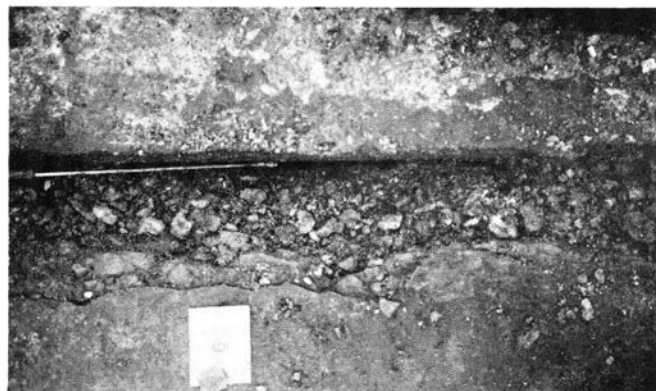
FIG. 80. EXTREMELY BAD SPALLING  
ALONG 4-IN. OPEN JOINT

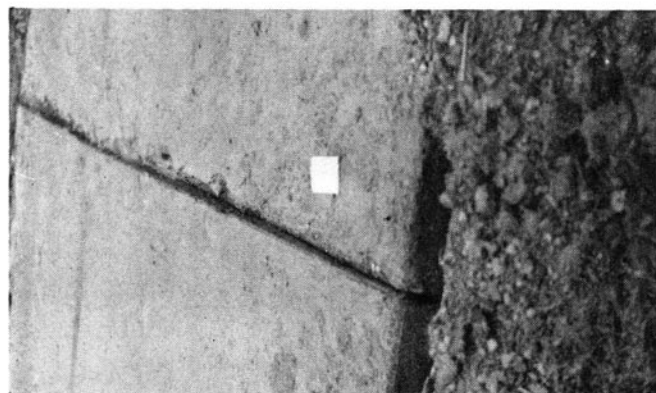
FIG. 79. SLIGHT SPALLING  
ALONG 4-IN. OPEN JOINT

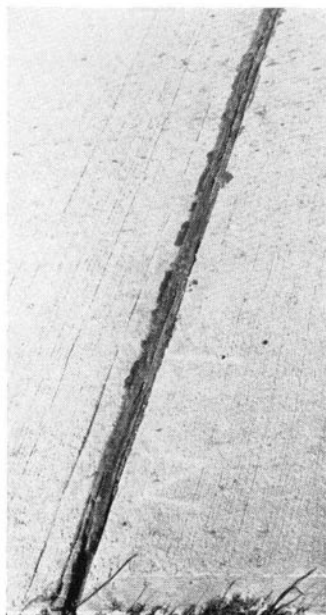
FIG. 82.  
TYPICAL CONDITION  
OF PREMOLDED CAP  
ON J-1 EXPANSION  
JOINT

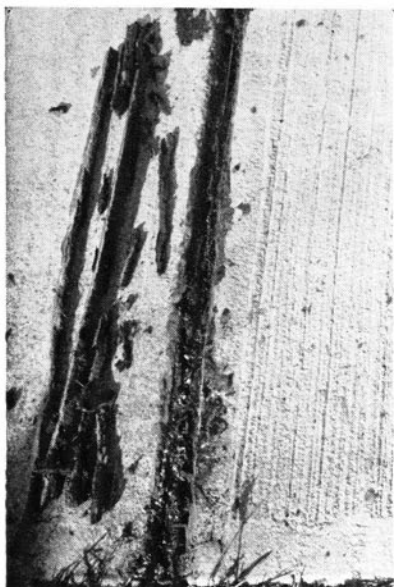
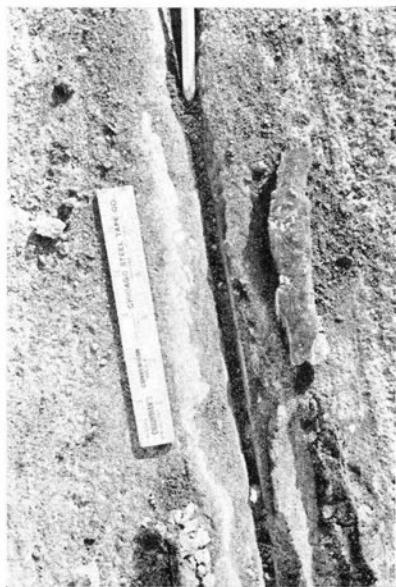
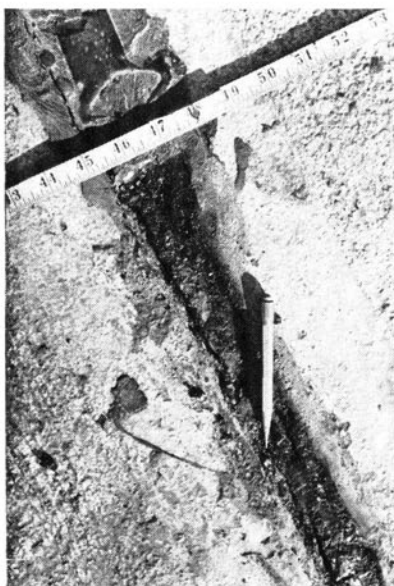
Figures 83 to 86, inclusive, are typical examples of the failure of caps and fillers to keep foreign material out of the several types of joints. Figure 83 shows a J-1 expansion joint with cap and filler removed, exposing a thick deposit of dirt and sand on top of the copper seal. The removed cap lying on the pavement shows how the caps become broken and split. A J-2 contraction joint with the filler removed to expose a thick layer of dirt on the copper seal is shown in Fig. 84. Figure 85 is a closeup of a fiber expansion joint with the bituminous filler removed, showing a deposit of dirt above the fiber material and the fiber pulled away from the concrete, leaving a space which eventually will become filled with foreign material. A closeup of a 4-in. open joint, showing the general condition of the filler in this type of joint, is given in Fig. 86. The photographs show conclusively that none of the caps or fillers was effective in keeping foreign material out of the various types of joints covered by the investigation.

FIGS. 83 AND 84 (ABOVE) AND 85 (BELOW, AT LEFT). TYPICAL EXAMPLES OF FOREIGN MATERIAL — RESPECTIVELY UNDER CAP AND FILLER ON J-1 EXPANSION JOINT, IN TOP OF J-2 CONTRACTION JOINT, UNDER FILLER ON FIBER EXPANSION JOINT

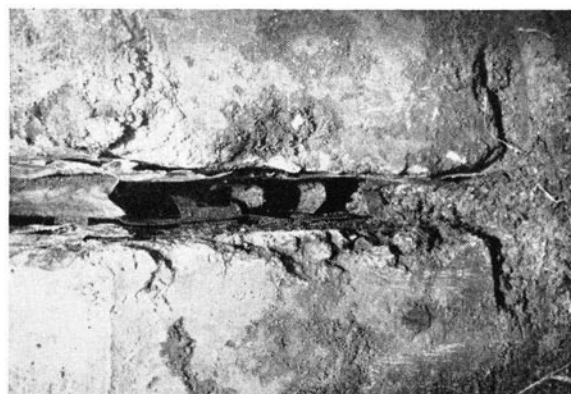
FIG. 87  
TYPICAL EXAMPLE OF DIRT  
IN J-1 EXPANSION JOINT

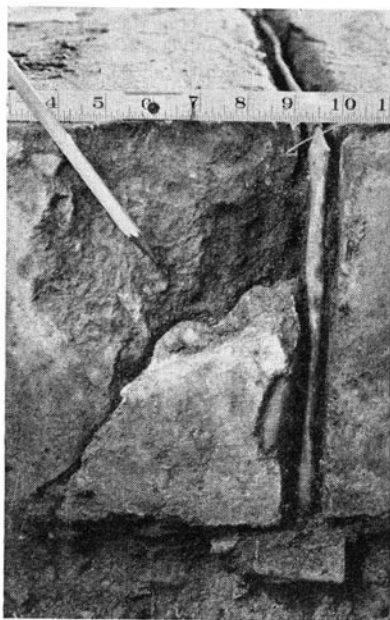
FIG. 90. TYPICAL EXAMPLE OF FRACTURE IN EDGE OF PAVEMENT  
DUE TO FOREIGN MATERIAL IN END OF JOINT

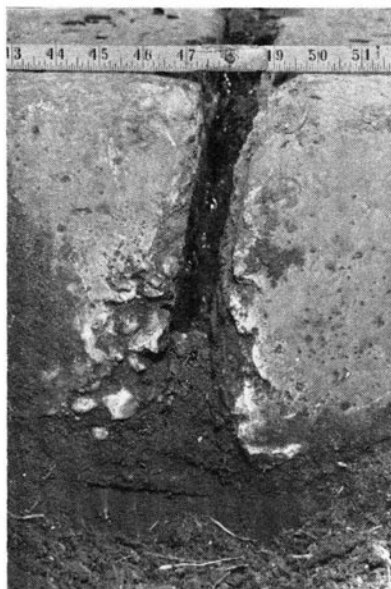
FIG. 91. PHOTOGRAPH SHOWING HOW SOIL FROM SUBGRADE WORKS UP INTO PREMOLDED JOINT

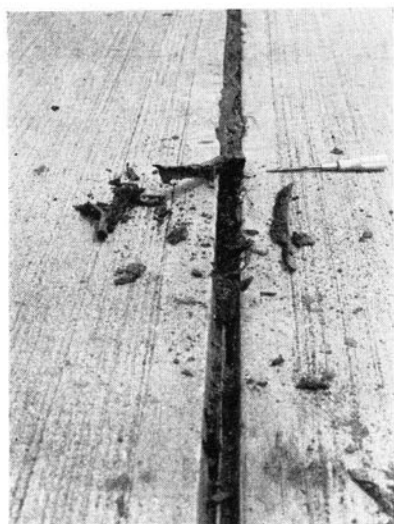
FIG. 108 (AT LEFT). J-1 EXPANSION JOINT AT STA. 5 + 75, WITH ASPHALT CAP  
LOOSENEED BY DIRT AND PARTIALLY REMOVED, SHOWING COPPER  
SEAL SHARPLY CRIMPED (AUGUST 12, 1941)

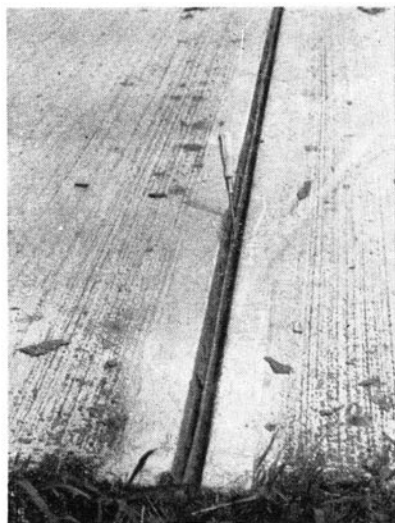
FIG. 109. J-1 EXPANSION JOINT AT STA. 5 + 00 WITH ASPHALT CAP REMOVED,  
SHOWING COPPER SEAL CRIMPED AND SPLIT (AUGUST 12, 1941)

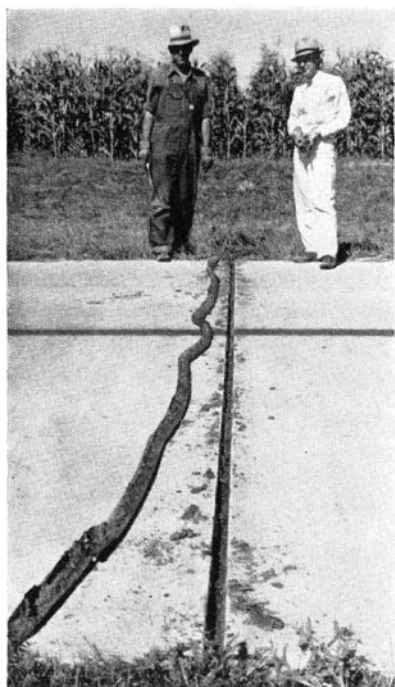
FIG. 112. J-6 EXPANSION JOINT AT STA. 13 + 00 SHOWING HOW POURED ASPHALT CAP, WHICH DID NOT ADHERE TO COPPER SEAL, BECAME LOOSENEED BY SOIL AND WAS EASILY REMOVED IN LONG STRIP (AUGUST 12, 1941)

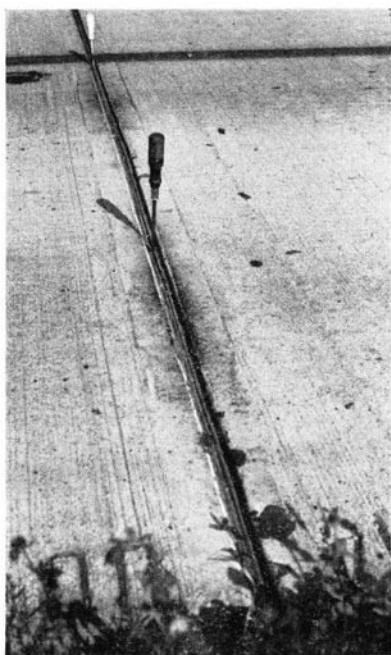
FIG. 113. J-5 EXPANSION JOINT AT STA. 14 + 00 WITH ASPHALT CAP REMOVED, SHOWING LONG SPLIT IN COPPER SEAL (AUGUST 25, 1941)

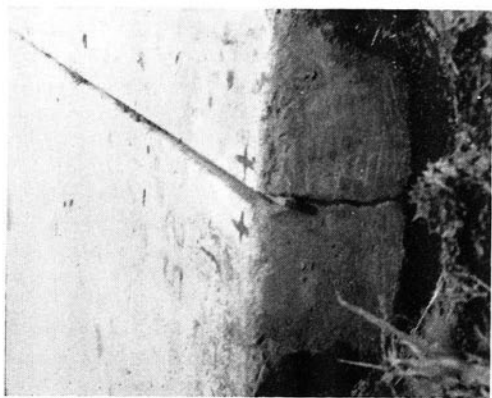
FIG. 116

115. J-3 Expansion Joint at Sta. 25+50 with Asphalt Cap Removed, Showing Splits in Copper Seal (August 25, 1941) . . . . .	224
116. Dummy Joint with Premolded Rubber Seal at Sta. 26+25, Showing Crack Formed as Intended but Opened So Wide That Rubber Seal Dropped to Bottom of Groove (July 23, 1941) . . . . .	228

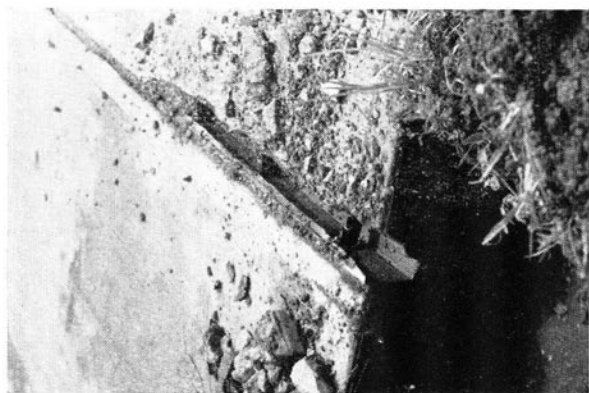
FIG. 118

117. J-10 Expansion Joint at Sta. 69+25, Showing Failure in Concrete Slab Induced by Plate Dowel (July 23, 1941) . . . . .	228
118. Same Joint as in Fig. 117, with Shattered Concrete Removed (July 23, 1941). This Failure Is Typical of Those Produced in Laboratory Tests of This Type of Joint . . . . .	228

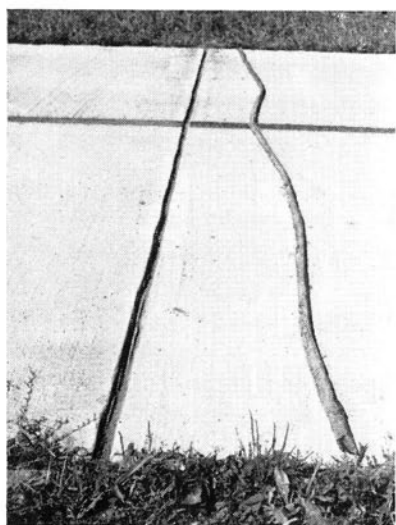
FIG. 119. J-8 EXPANSION JOINT AT STA. 73 + 00, SHOWING LOOSE ASPHALT CAP REMOVED TO EXPOSE SHARPLY CRIMPED COPPER SEAL (AUGUST 12, 1941)

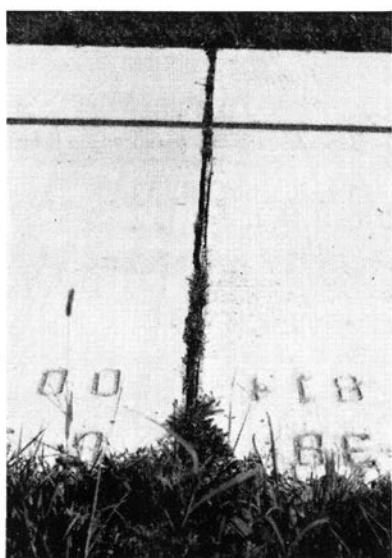
FIG. 121. PREFORMED RUBBER EXPANSION JOINT AT STA. 81 + 00, SHOWING WEEDS GROWING IN SOIL COLLECTED BETWEEN LOOSE FILLER AND CONCRETE. RUBBER SHOWS SOME DETERIORATION (AUGUST 25, 1941)

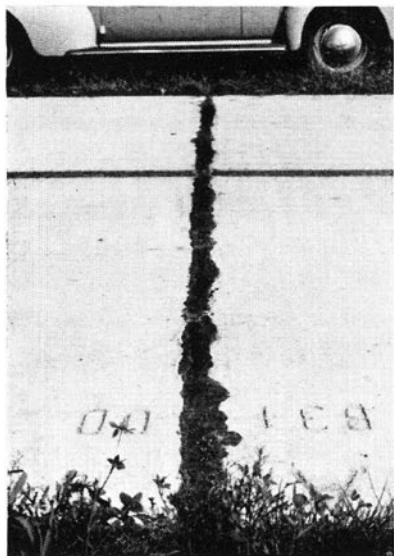
FIG. 123 (AT LEFT). BITUMINOUS PRE-MOLDED EXPANSION JOINT AT STA. 83 + 00, SHOWING EXCESSIVE EXTRUSION CAUSED BY POURING ASPHALT SEAL ON TOP OF JOINT. COMPARE WITH JOINT WITHOUT SEAL IN FIG. 122 (AUGUST 25, 1941)

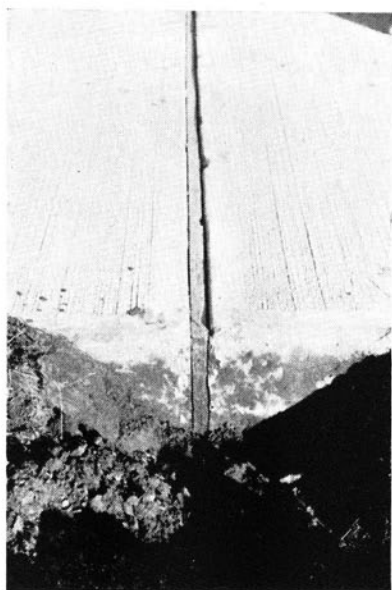
FIG. 125. WOOD EXPANSION JOINT AT STA. 102 + 65. BOARD IS SOUND AND TIGHT IN JOINT WITH VERY THIN LAYER OF SILT ON EACH SIDE. TOP WITHOUT ASPHALT SEAL IS ONLY SLIGHTLY SCARRED BY TRAFFIC ABRASION (OCTOBER 10, 1939)

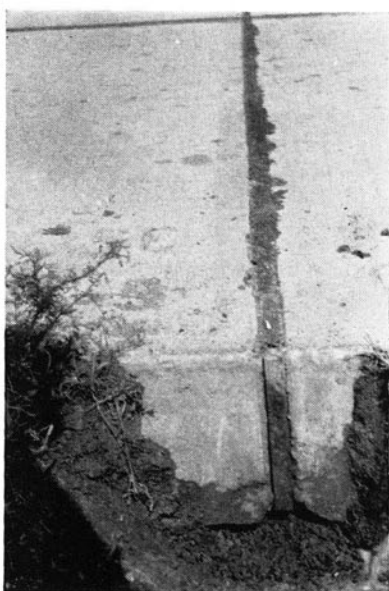
FIG. 126. WOOD EXPANSION JOINT AT STA. 105 + 35, SHOWING ASPHALT SEAL, ADDED SHORTLY AFTER INSTALLATION, STILL IN GOOD CONDITION. WOOD SOUND AND PRACTICALLY FULL THICKNESS. TIGHT ON RIGHT SIDE,  $\frac{1}{32}$ -IN. LAYER OF SILT ON LEFT SIDE (JULY 23, 1941)

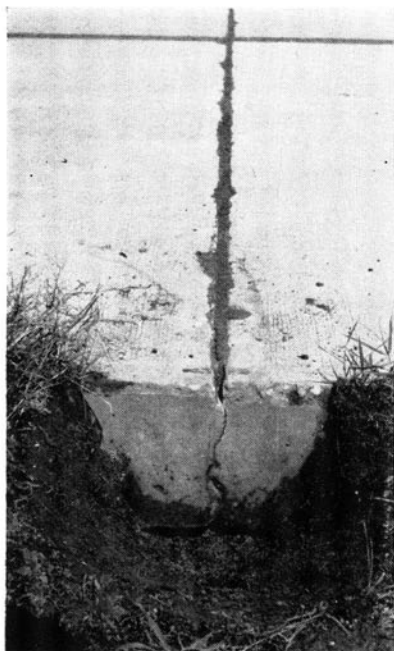
FIG. 128. DUMMY CONTRACTION JOINT AT STA. 98 + 40, SHOWING TYPICAL CRACK FORMED BY 1-IN. GROOVE (JULY 23, 1941)

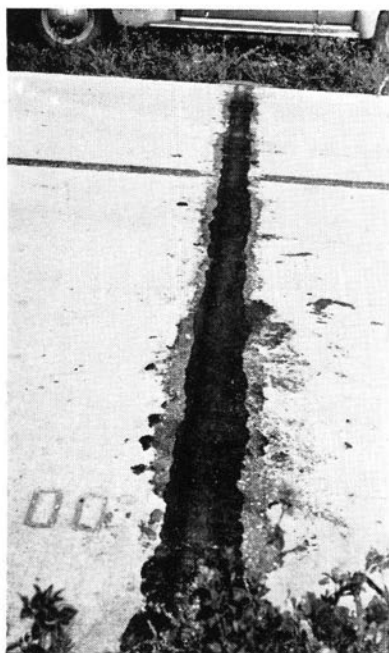
FIG. 129. VIEW SHOWING CONDITION OF 4-IN. OPEN JOINT AT STA. 88 + 00 ON JULY 8, 1941. APPROXIMATE CLOSURE SINCE INSTALLATION ON JUNE 13, 1938, 2.8 IN.
